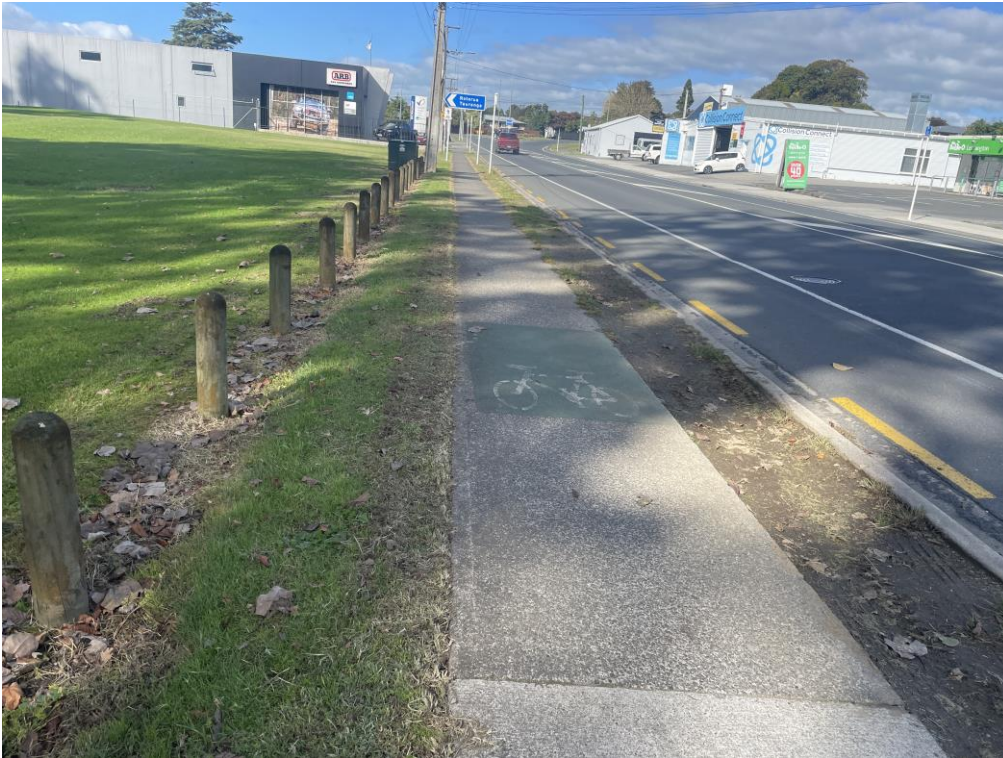
Figure 1: Existing cycle path marking on northern footpath of Cook Street

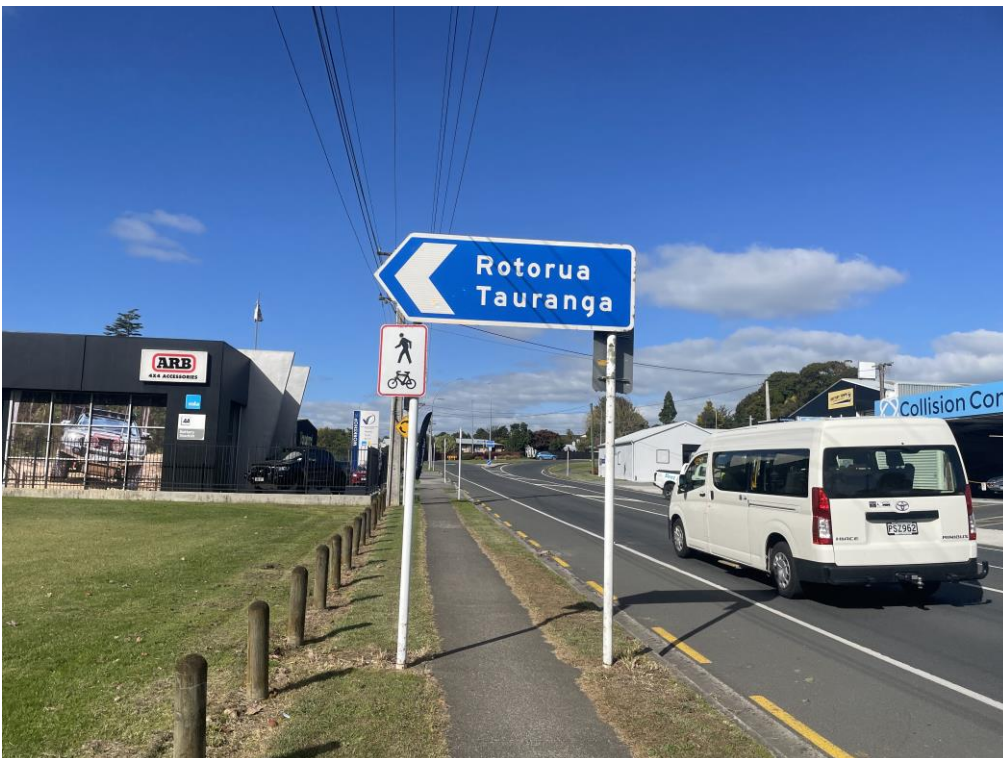
Figure 2: Shared path sign installed on existing

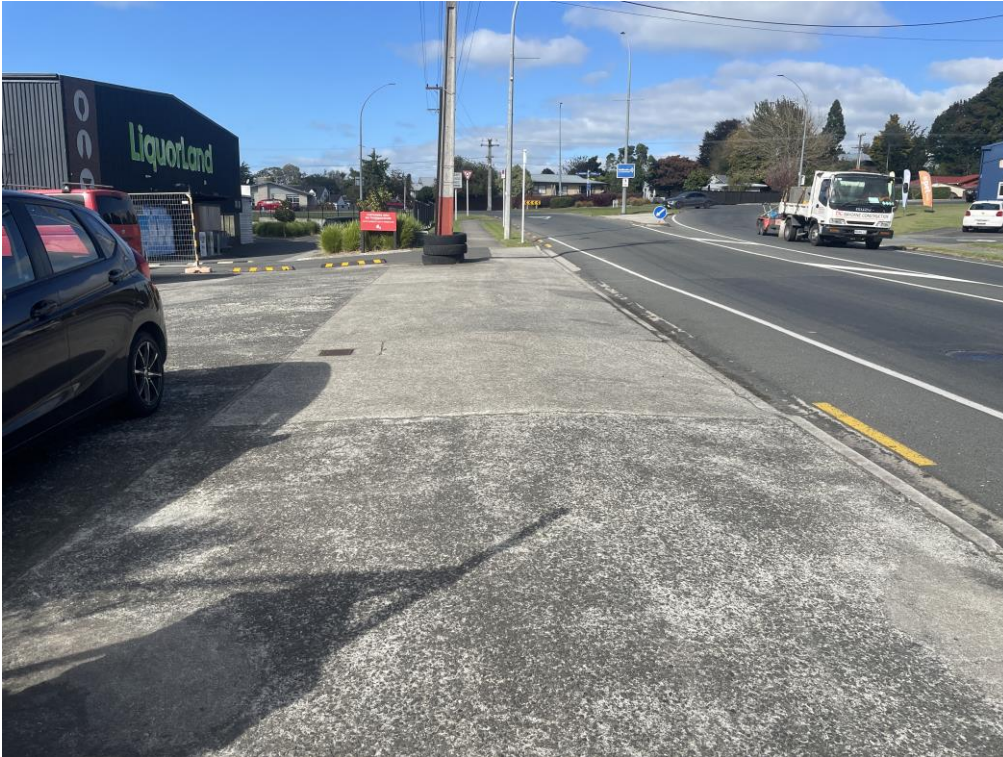
Figure 3: Large and high-use driveways on Cook Street

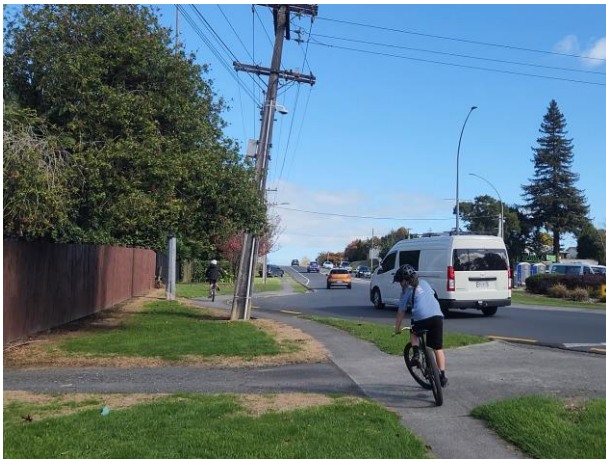
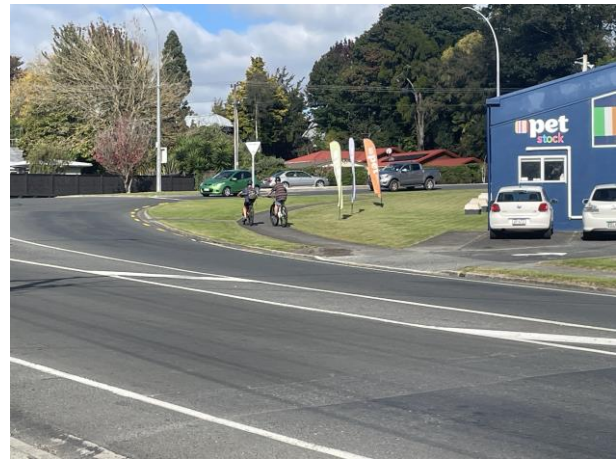
Figure 4: Cyclists observed using the footpath

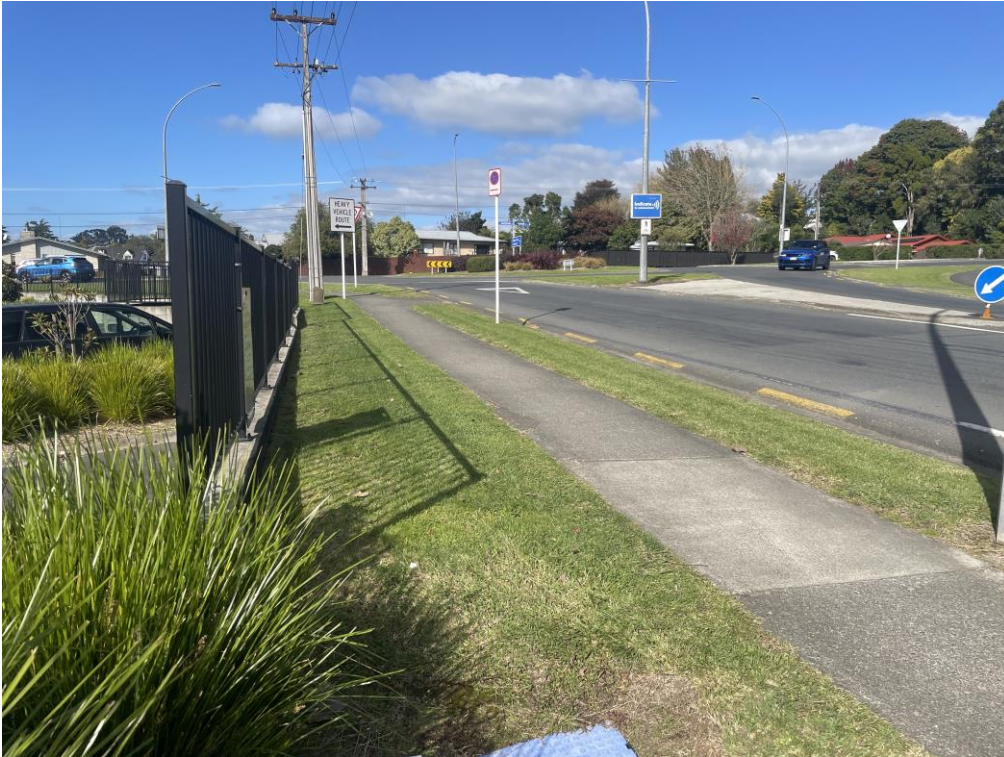
Figure 5: 'Heavy Vehicle Route' sign indicate high volume of heavy commercial vehicles

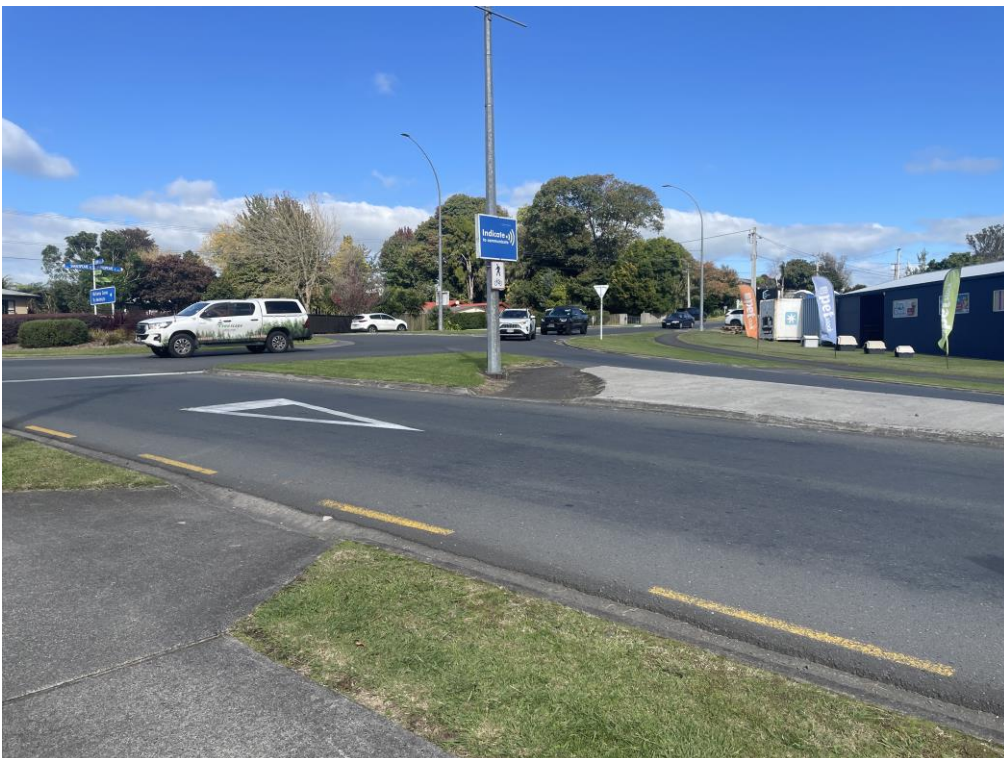
Figure 6: Shared path sign installed at the traffic median island

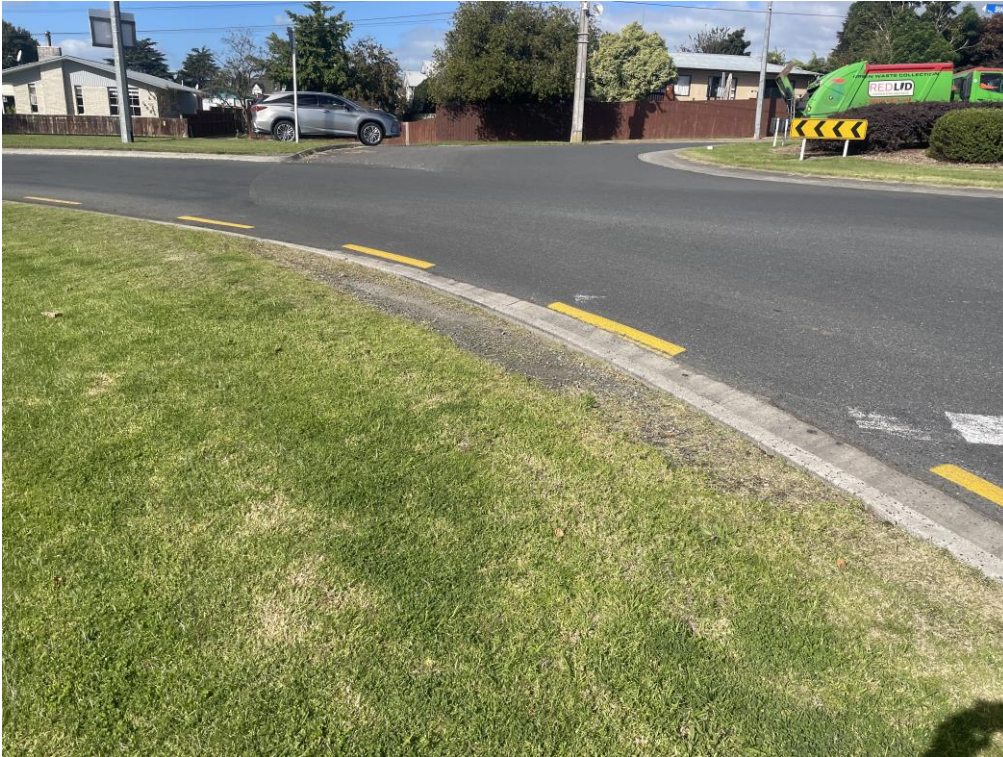
Figure 7: Skid marking indication of heavy commercial vehicle tracking encroach onto the berm area

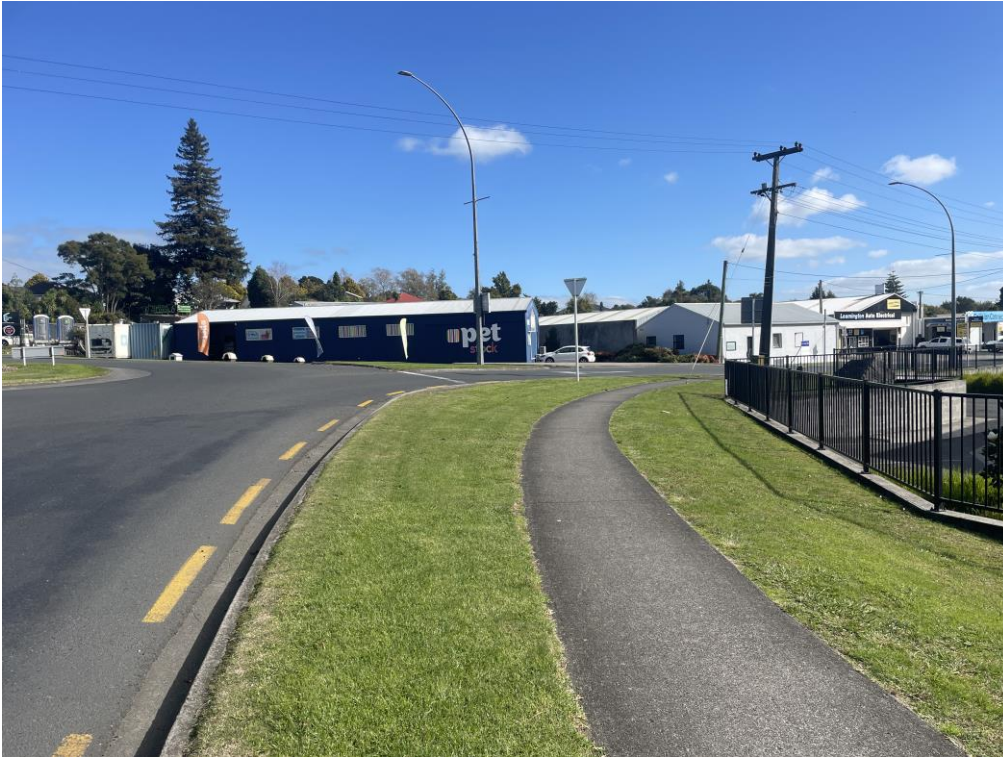
Figure 9: Clear visibility from the western side of the proposed raised courtesy crossing

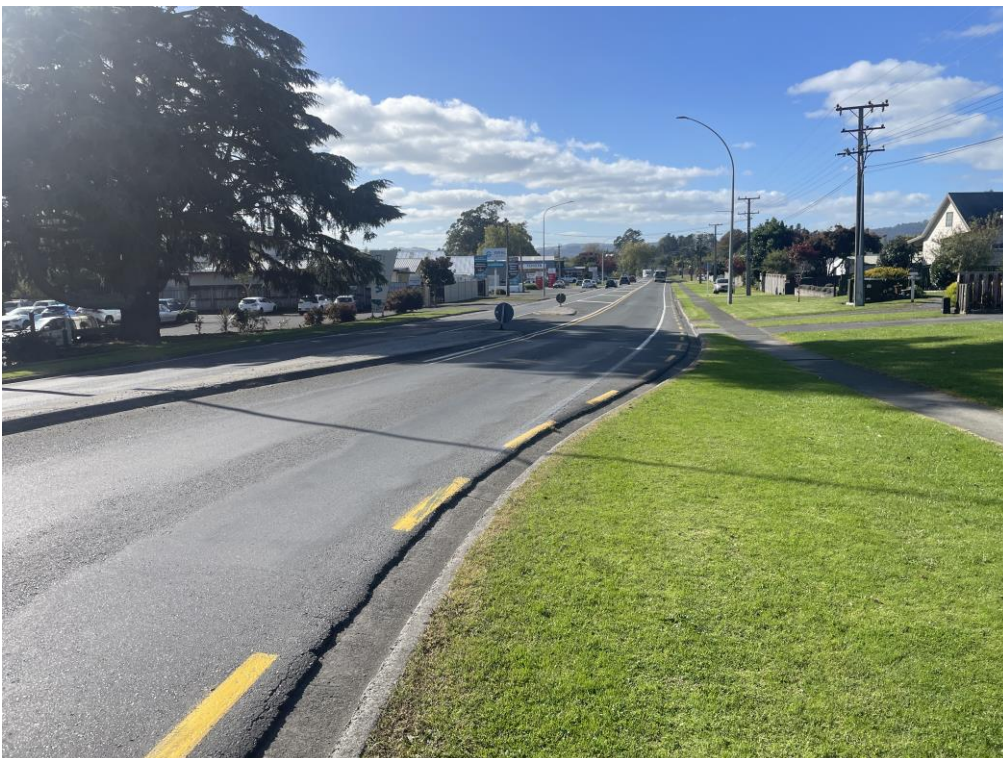
Figure 10: Clear visibility from the eastern side of the proposed raised courtesy crossing

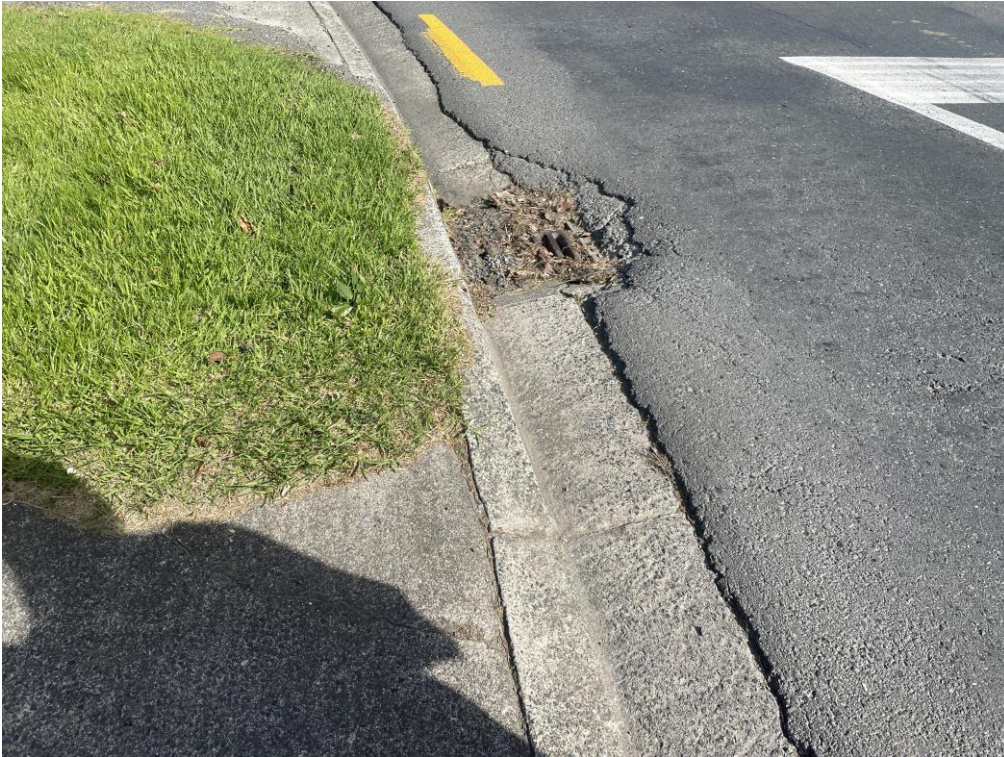
Figure 11: Blocked catchpit

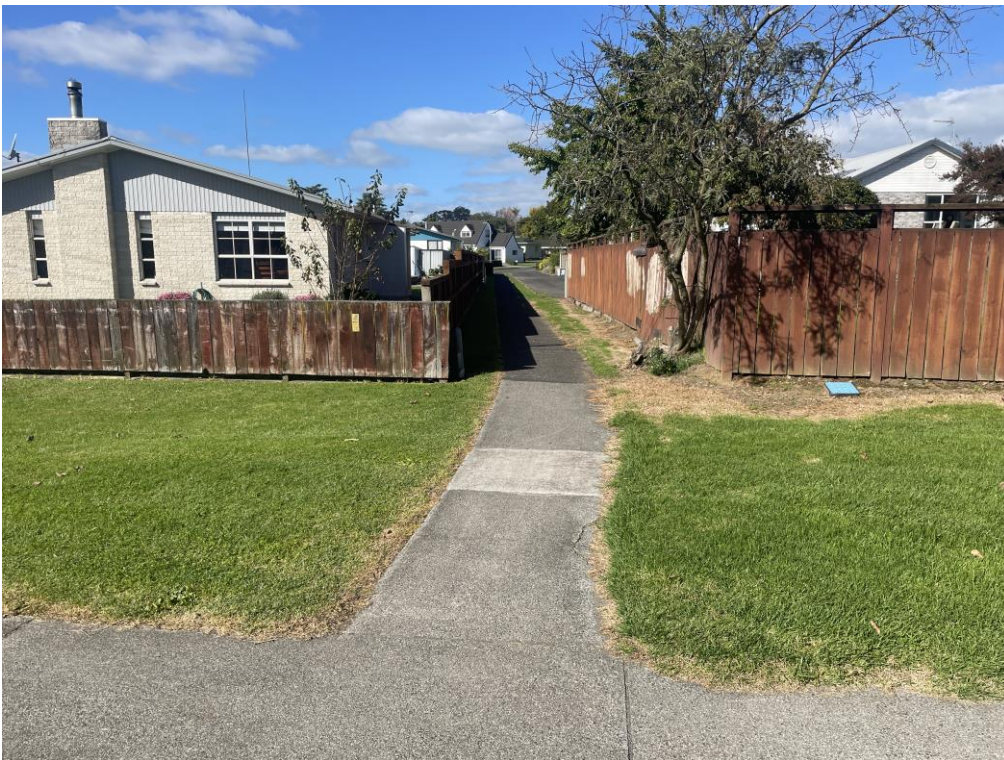
Figure 12: Access aligning with the eastern side of the proposed raised courtesy crossing

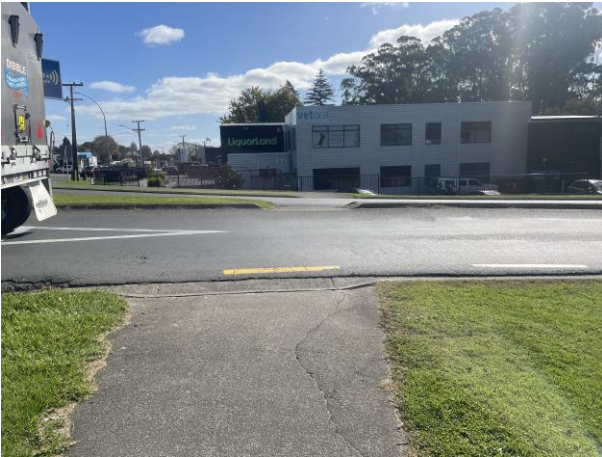
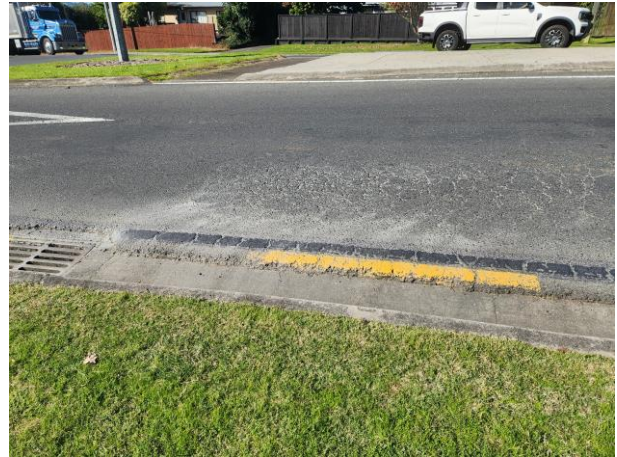
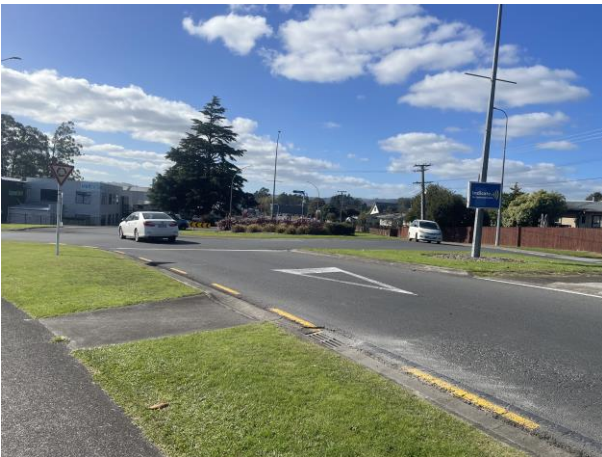
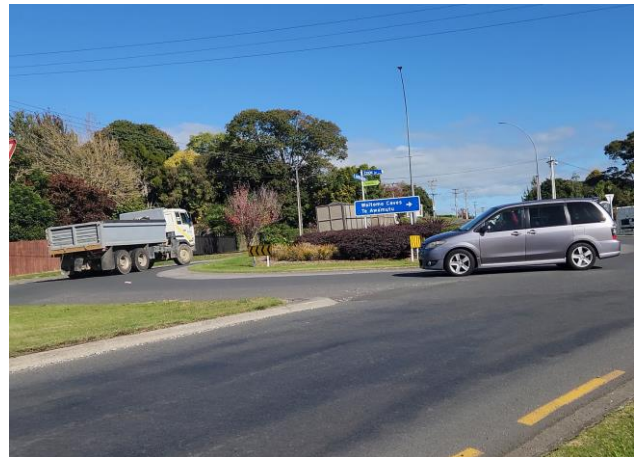
Figure 13: Deteriorating footpath and pavement condition

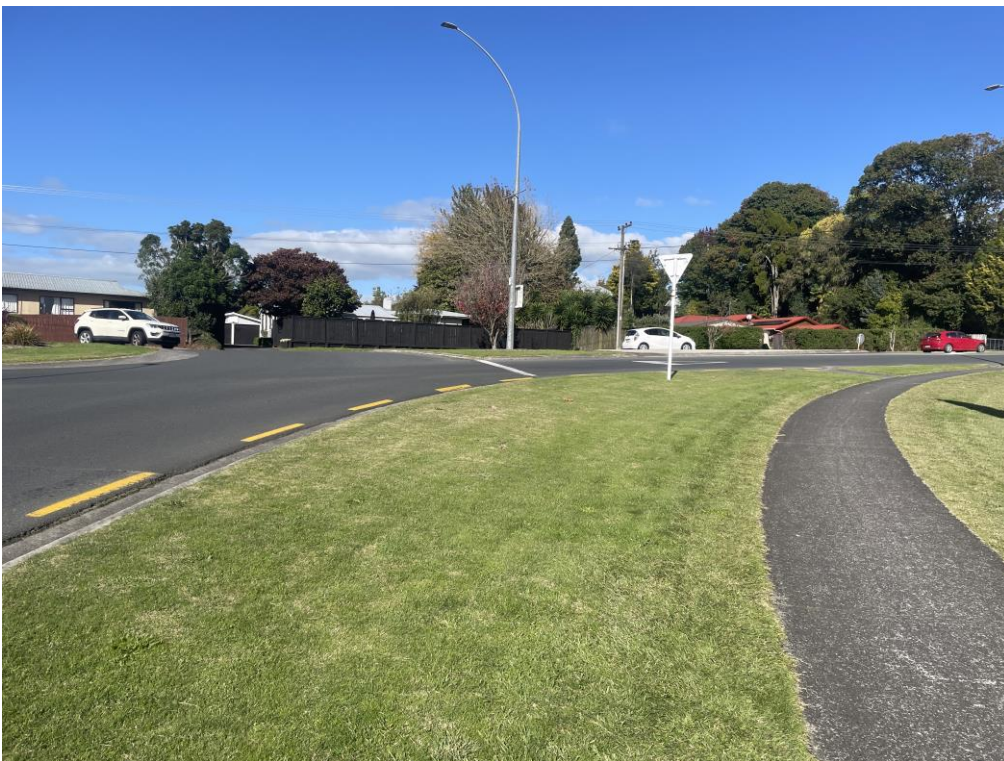
Figure 15: Clear visibility from the southern side of the existing crossing on Cook Street

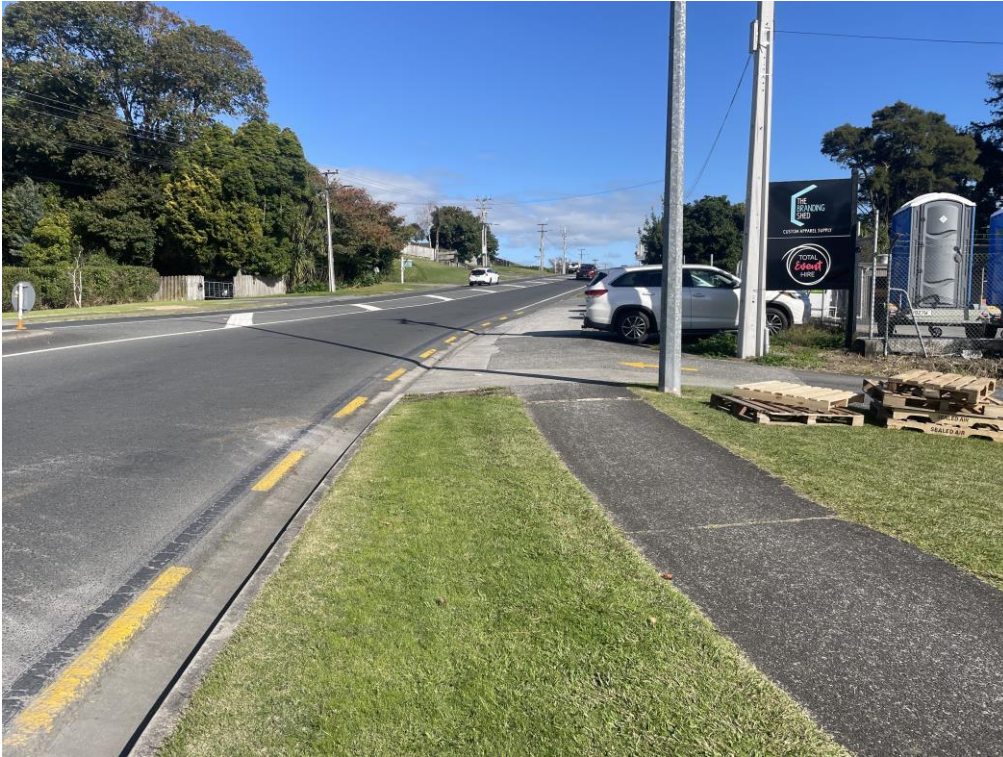
Figure 16: Clear visibility from the western side of the existing crossing on Shakespeare Street southern approach

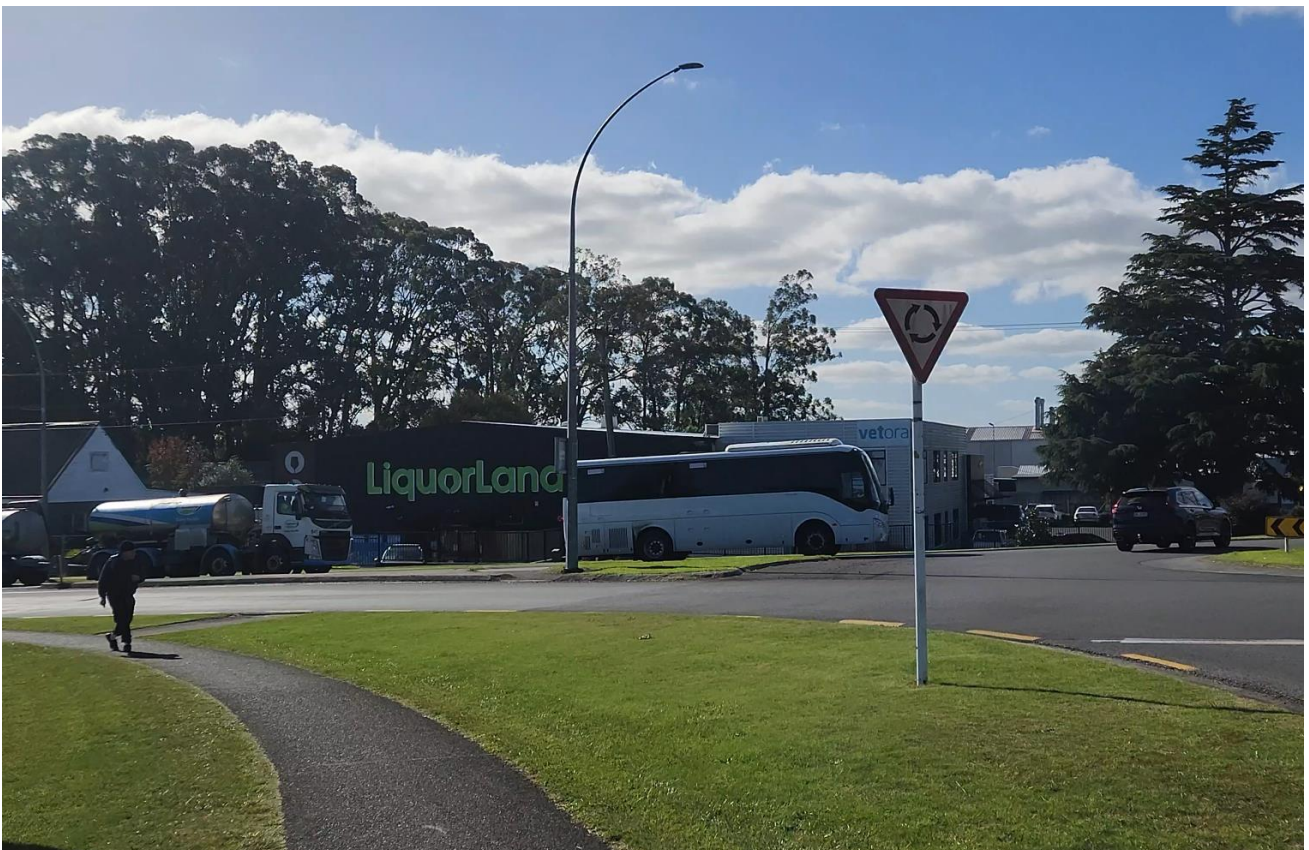
Figure 17: Tour coach observed using the roundabout

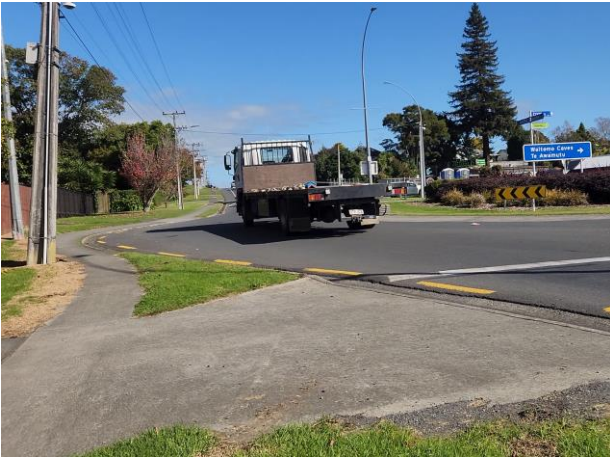
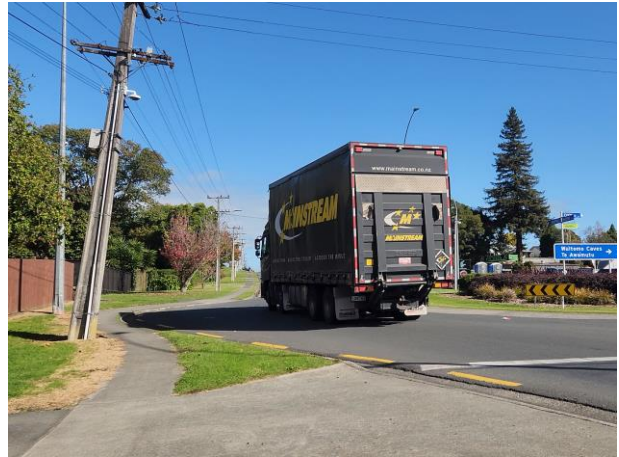
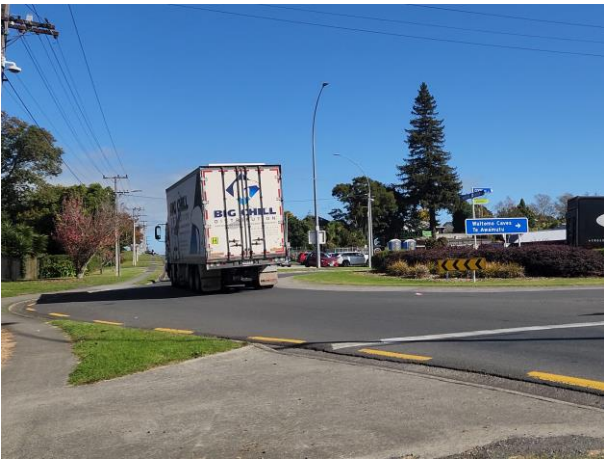
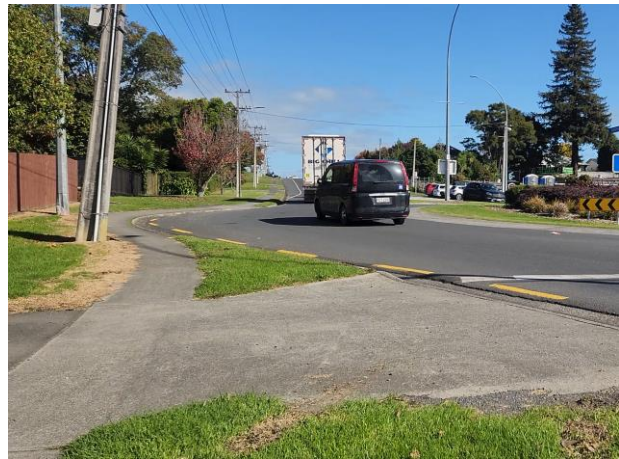
Figure 18: Areas of circulation lane not being used by vehicles

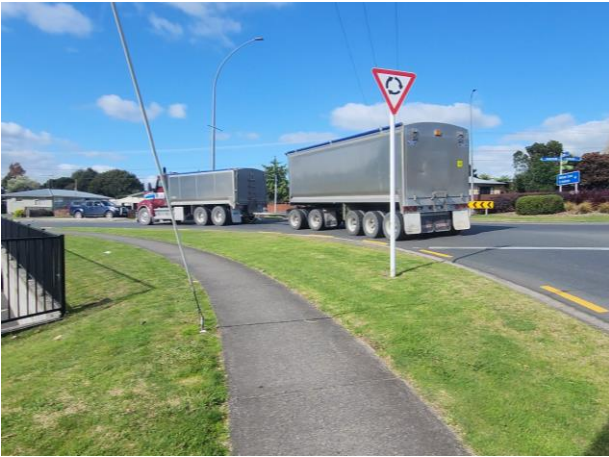
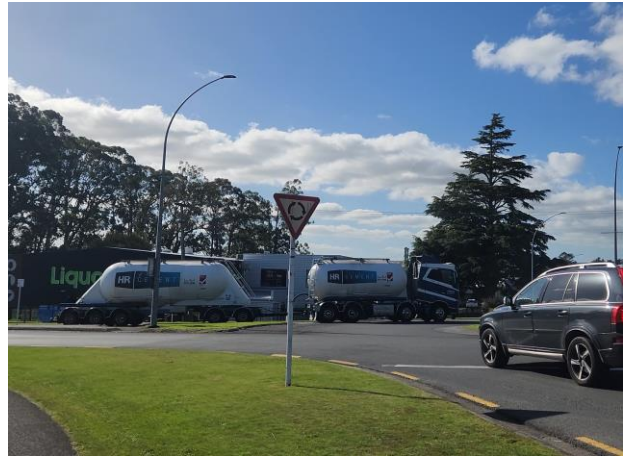
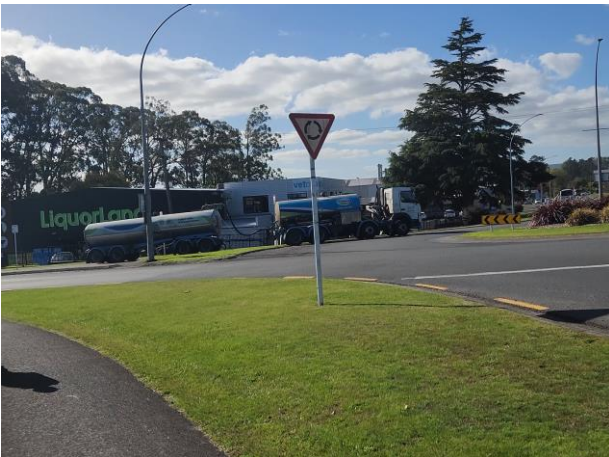
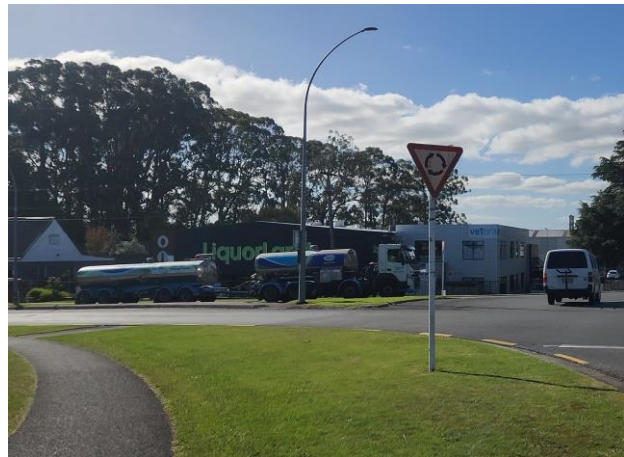
Figure 19: Truck and trailers observed using the roundabout
